Suez Canal Clearance Operation, Task Force 65

Task Force 65  
Norfolk, Virginia

May 1975

# FINAL REPORT

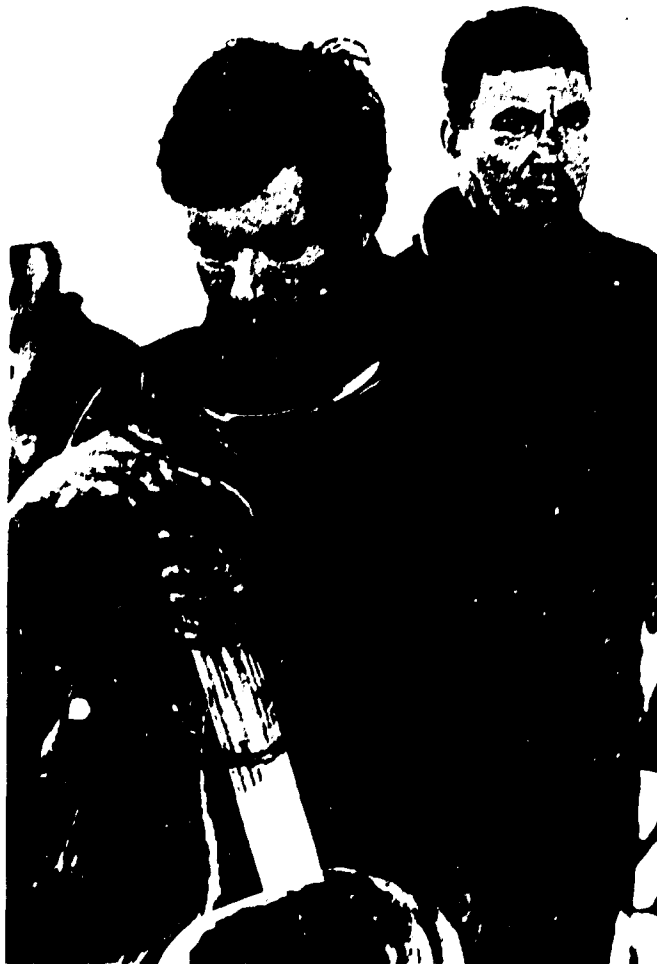
Salvage diver prepares for OXY-ARC cutting on hull of SS MECCA.

Salvage operations commenced on 29 May. The initial task was to remove the superstructure using oxy-arc and explosive cutting with lifts by an 80 ton floating crane. This was completed by 29 June. Initial problems with oil removal were solved by persistence and pumping. Explosive and oxy-arc cutting on the main hull continued through the summer with sections being removed by heavy cranes to dry dump at KM 3. Ten cuts were made dividing the wreck into 11 pieces for lift. Heavy lift cranes Thor and Roland made double lifts on three pieces as shown in Figure 5. In October when lifting the final section for the first time, one chain sling completely pulled through the section. It was decided to further lighten the section by removal of structure and machinery. Heavy cranes returned to lift the final section after operations were completed in the southern and central region of the canal. The final section of SS MECCA was lifted to dry dump on 18 December.

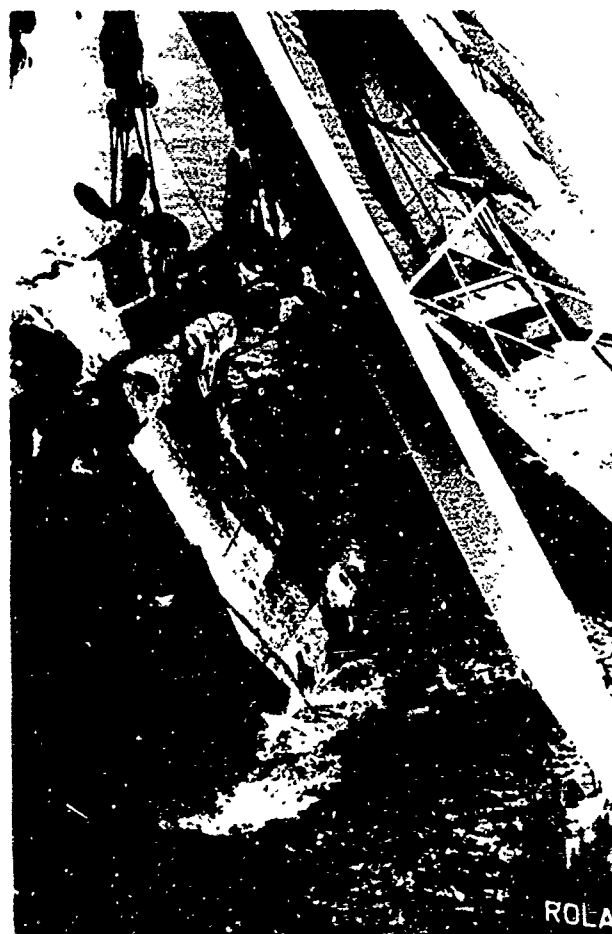
Figure 5. Heavy Cranes ROLAND and THOR double lift MECCA stern section.

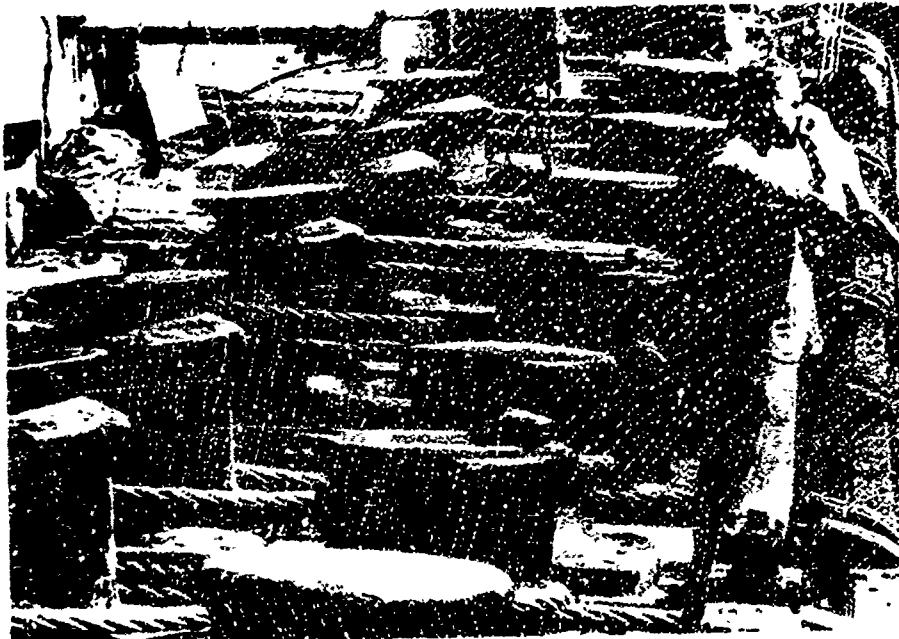
Lifting wires in place on YHLC for ballasted lift.

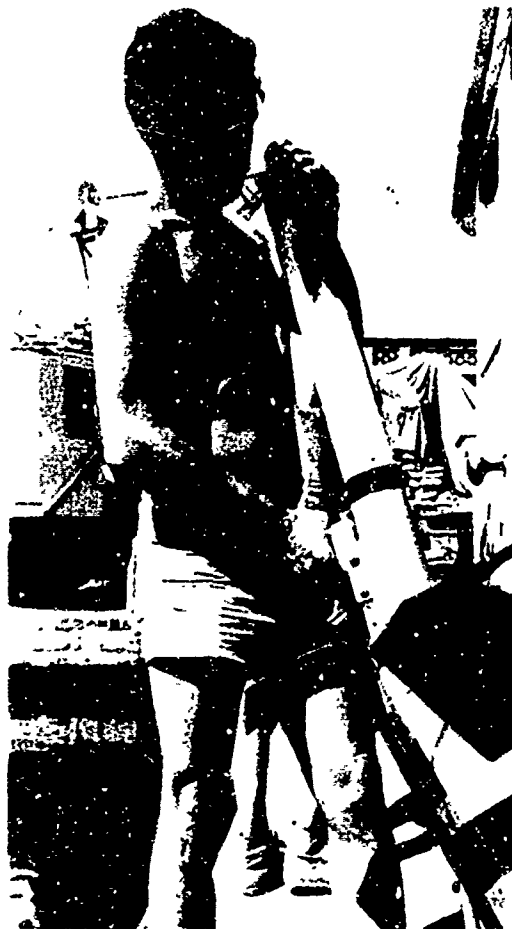
Figure 11. U.S. Navy EOD Technician prepares Side Scan Sonar Towfish for search operation.

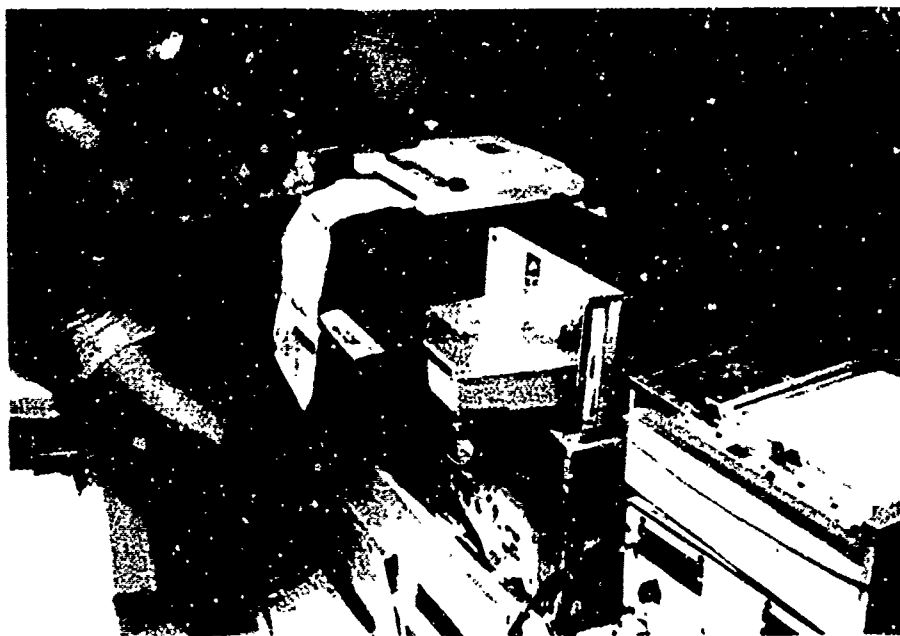
Figure 12. Side Scan Sonar Recorder and precision navigation and plotting equipment as installed on the Sonar Search Boat.

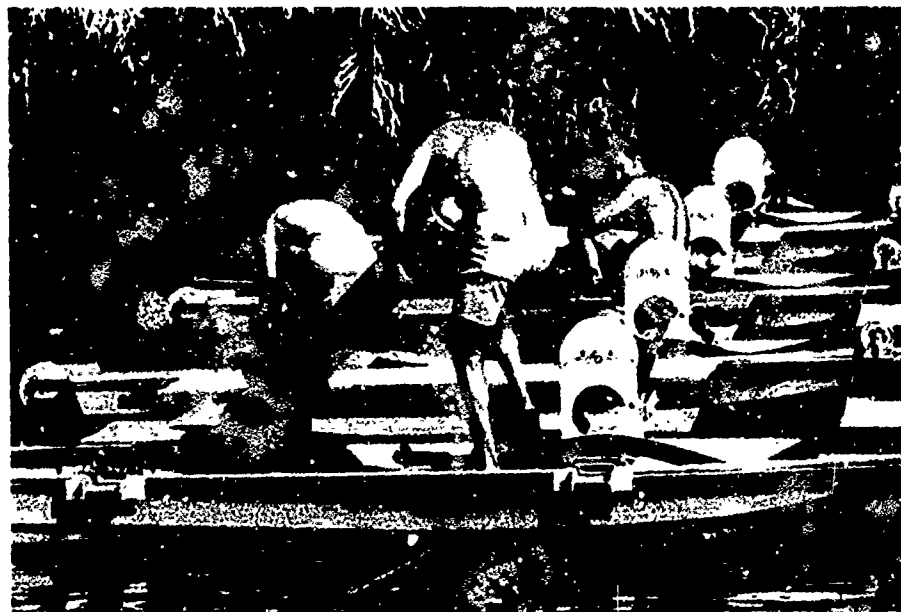
Assembly of the Ganged Magnetometer Sensor System.

A special ganged magnetometer was developed and tested in CONUS. This system arrived in-country in early October. It was used to conduct precise navigationally controlled search of the Great Bitter Lake channel and anchorage area. The Great Bitter Lake had proved a difficult area for effective sonar search due to the presence of very saline bottom water layers. Based on initial search data, the ganged magnetometer system proved very effective at detecting and localizing magnetic contacts in the Great Bitter Lake. However, the initial area searched indicated a very large number of ferrous contacts would be found in the Great Bitter Lake, possibly as many as ten thousand. Diver investigation of initial contacts identified no UXO's. Initial diving also identified the magnitude of several problems as follows: (1) In most areas of the lake, ferrous contacts were buried in the sediment. Search with a Mark 10 detector or probe was required. (2) In a significant portion of the lake, this difficulty was compounded by the very dense high salinity layer which covered the bottom. Divers needed to wear up to fifty five pounds total weight in order to penetrate this layer. Once in the layer, visibility was zero and contacts were again buried in soft sediment. The odor of hydrogen sulfide was very strong and if water entered a divers facemask, eye and nasal passage irritation was immediate. (3) With the large amount of weight required, divers had to be tethered for safety. The combination of circle search line, buoy line, tether, zero visibility, and no communication with the surface, created a hazardous situation for open circuit scuba equipped divers. (4) Information provided by BUMED indicated the observed dissolved hydrogen sulfide level exceeded recommended safety limits.

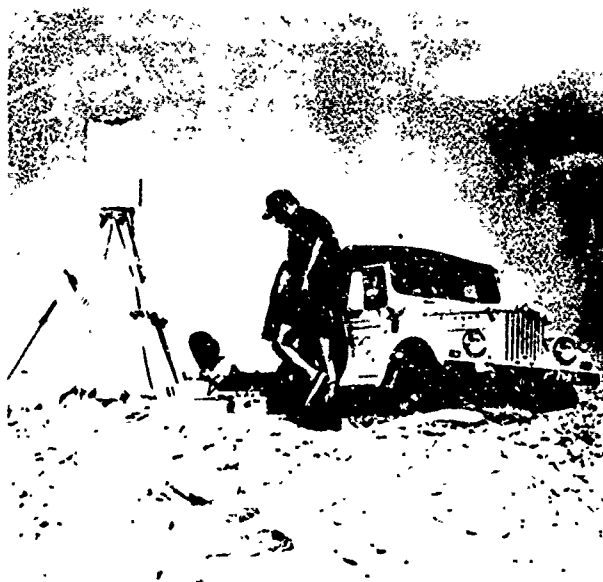
Cubic Tripod Responder Site.
